# ASBESTOS SURVEY OF THE FEDERAL BUILDING AND COURT HOUSE AT 450 GOLDEN GATE AVENUE, SAN FRANCISCO, CALIFORNIA

FEBRUARY 1983

NBSIR 83-2650

James H. Pielert

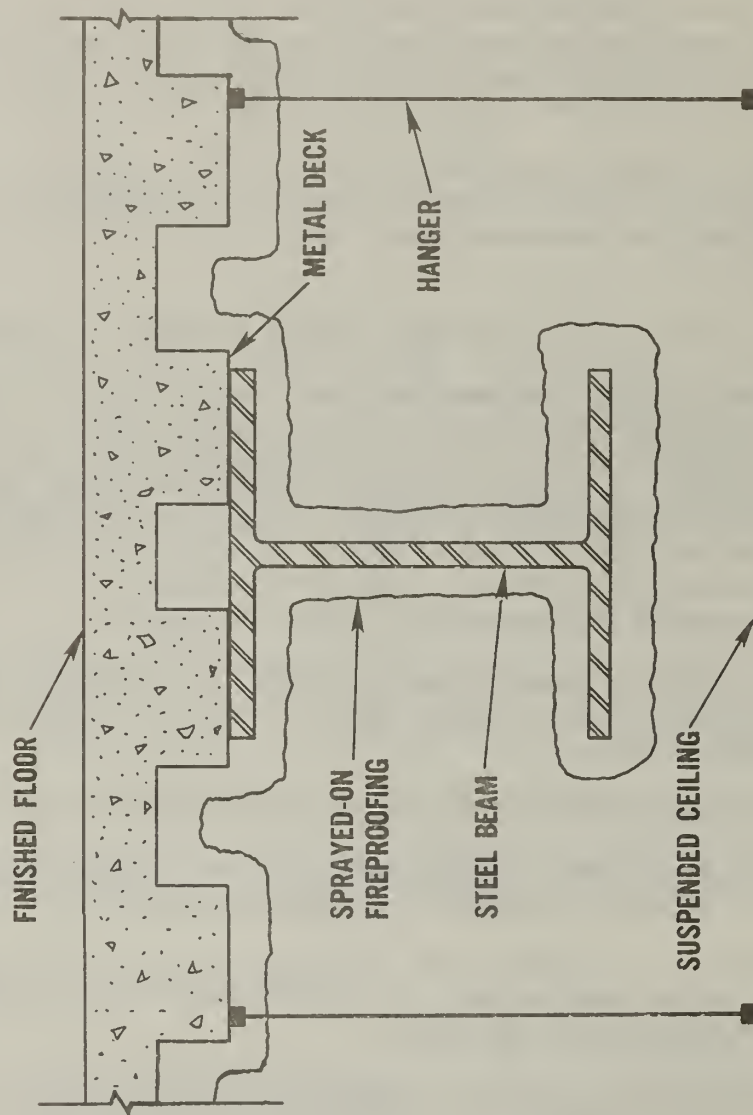
Figure 2. Schematic of typical composite steel/concrete floor construction

The building is a steel frame structure with composite floors constructed of light gage steel deck and cast-in-place concrete. The deck used was a standard structural deck with built-in wireways but no air movement cells. A schematic cross-section drawing of typical floor construction is shown in figure 2.

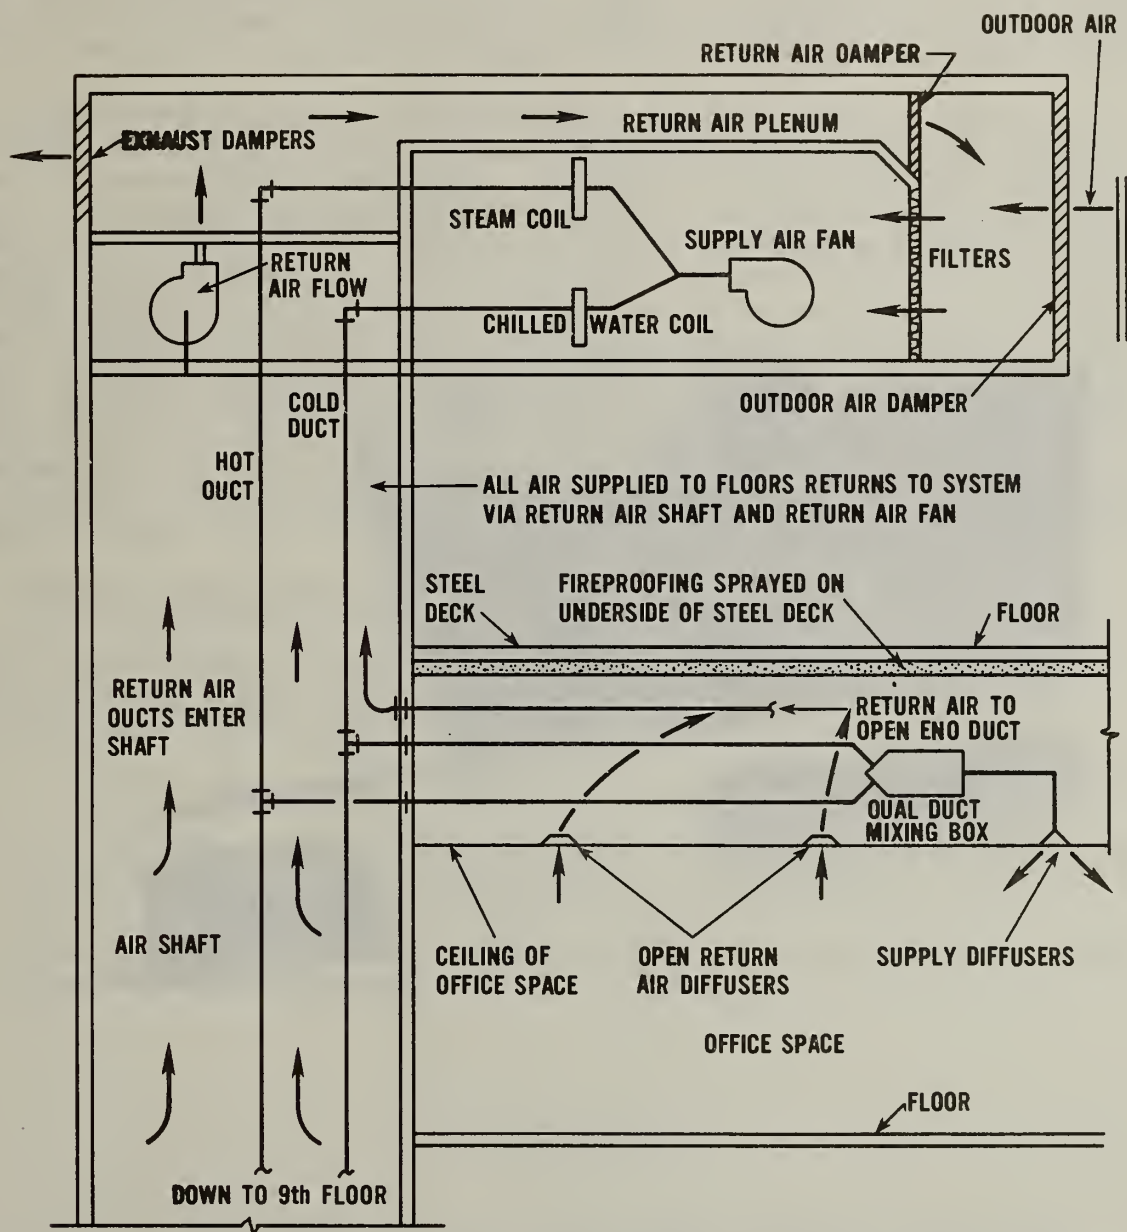
Figure 3. Schematic of typical air handling system

The HVAC system is a four-pipe system consisting of six separate air handling systems providing air flow to all spaces in the building. The air handling systems are such that four of these systems feed down from the twentieth floor to the ninth and two systems feed up from the basement areas through the eighth floor. These systems are dual duct systems with separate steam heating coils and chilled water cooling coils in each system with duct mixing boxes as the terminal units. The system has the ability to cool or heat at any time that the air handling units are running. The portions of the HVAC system observed were consistent with the building drawings. A schematic drawing of a typical air handling system for occupied office areas is shown in figure 3.

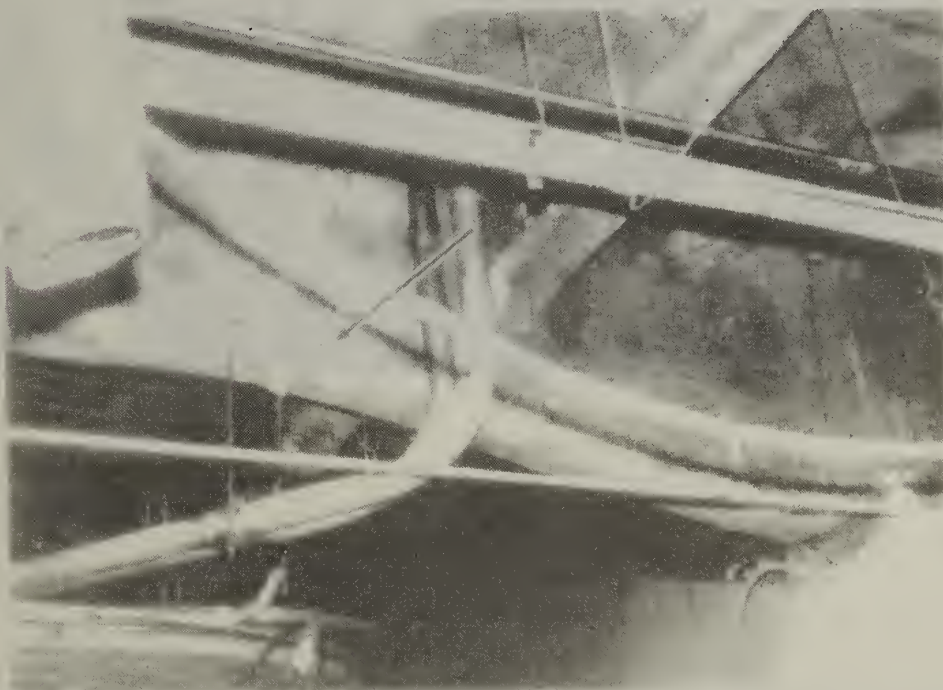
Figure 5 shows the air plenum area in Room 15219 with the suspended ceiling removed. Damage to fireproofing can be seen in figure 6 (addition of piping), figure 7 (addition of wall partitions), and figure 8 (addition of pipe hanger to beam flange).

Figure 6. Damage to fireproofing due to renovation of plumbing system in Room 15219

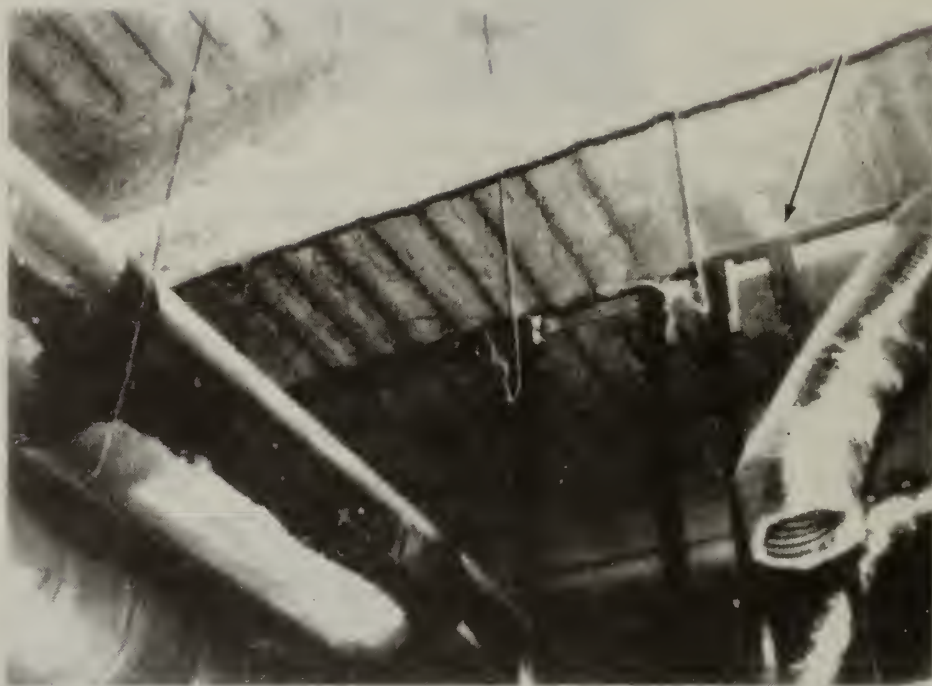
Figure 7. Damage to fireproofing due to addition of partition system in Room 15219

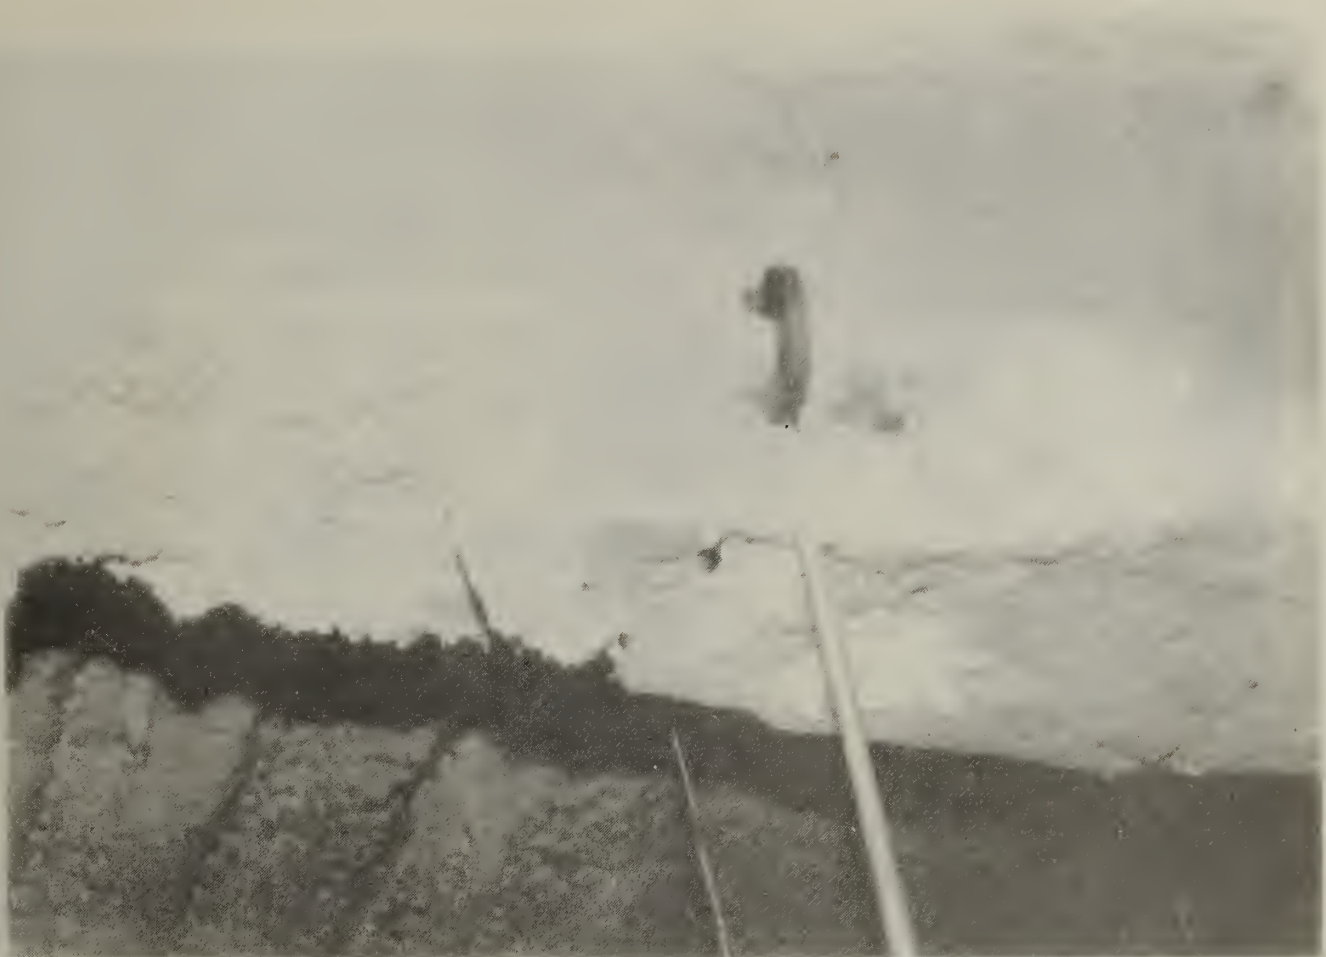
Figure 8. Damage to fireproofing due to addition of pipe hanger to beam flange adjacent to Room 15219

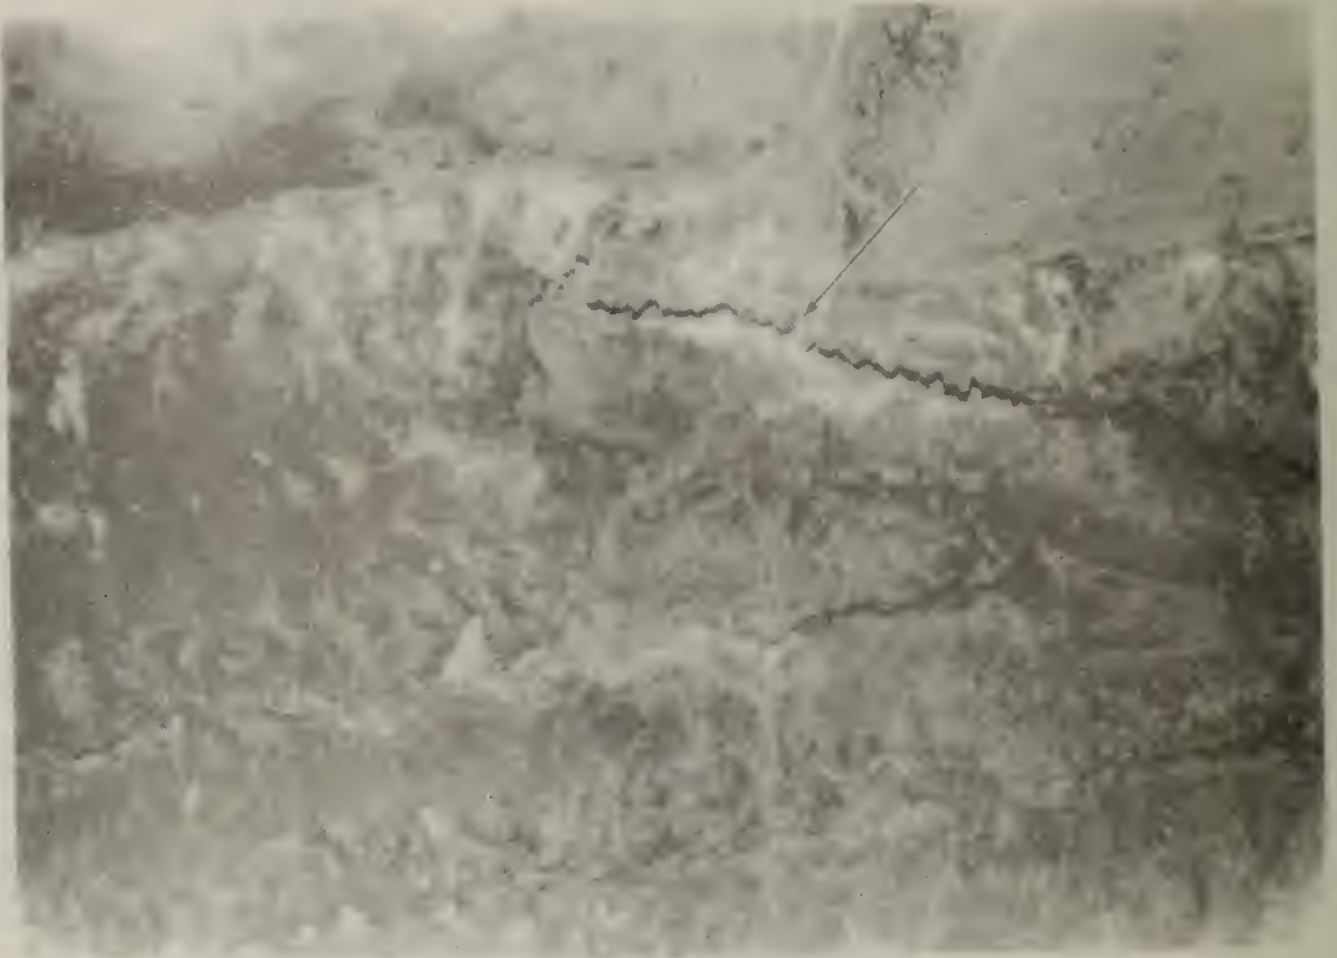
Figure 11. Naturally deteriorating fireproofing on structural members  
in main kitchen storage Room 2212

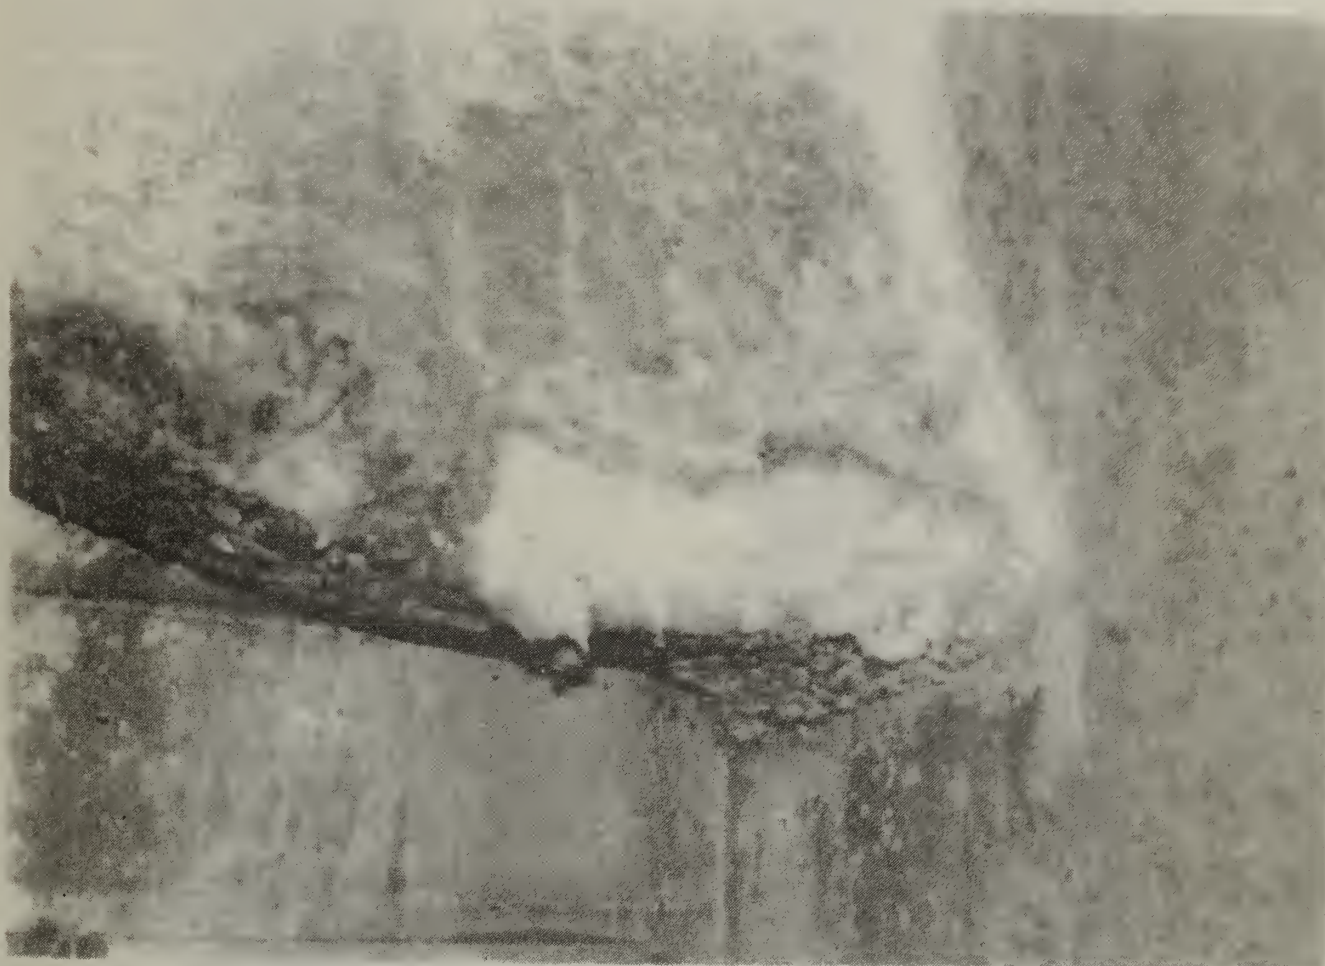
Figure 12. Physical damage to fireproofing on beam in Main Kitchen Storage Room 2212

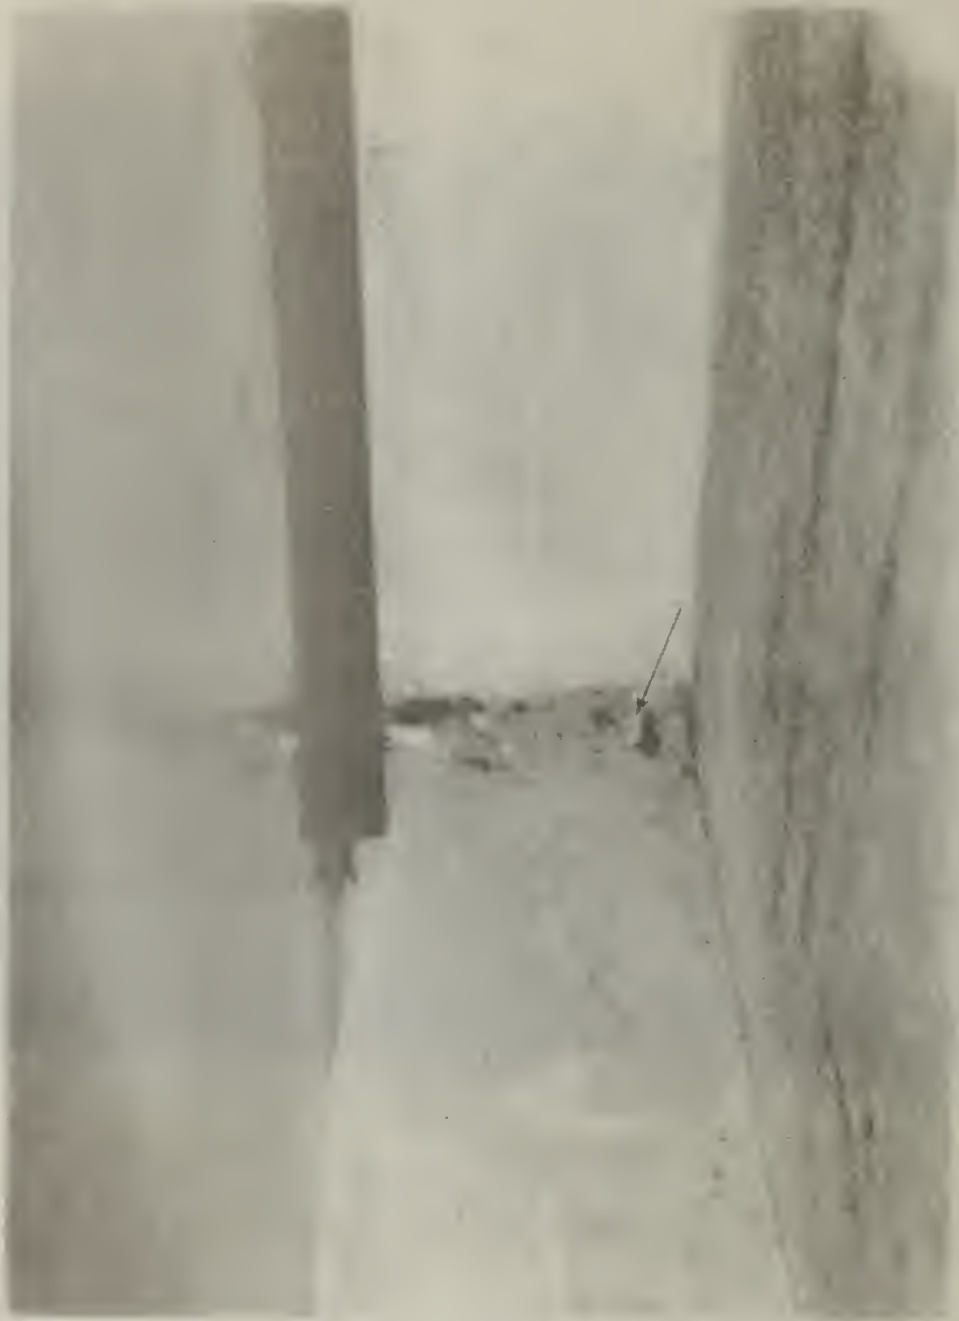
Figure 13. Pieces of fireproofing on floor of Main Kitchen Storage Room 2212

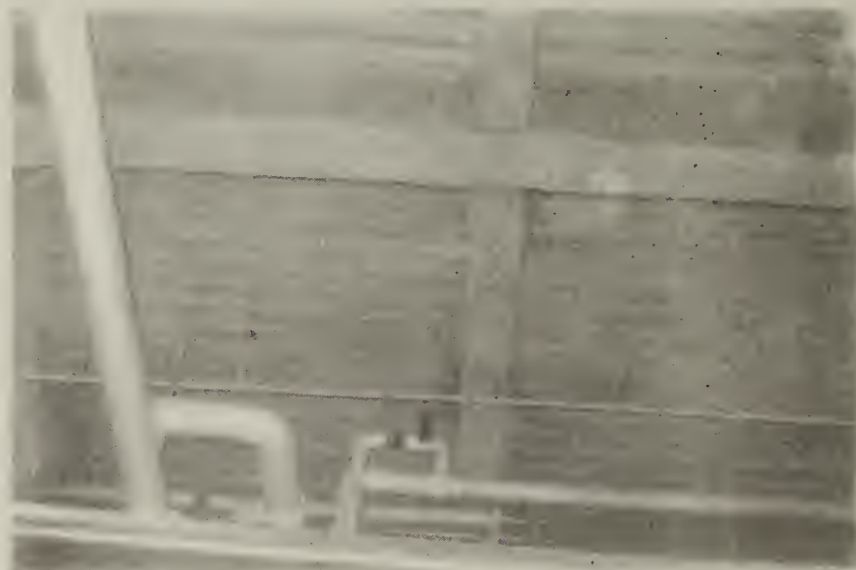
Figure A.2. Room 20407C - Ceiling of outside air supply plenum fan room with no apparent damage to fireproofing.

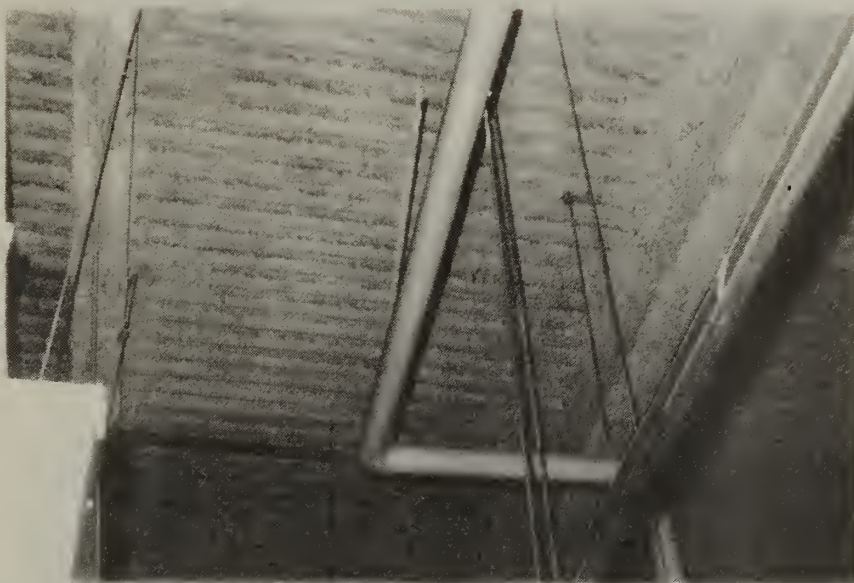
Figure A.3. Ceiling of equipment room of penthouse with no apparent damage to fireproofing (note original attachment of hangers to steel deck).

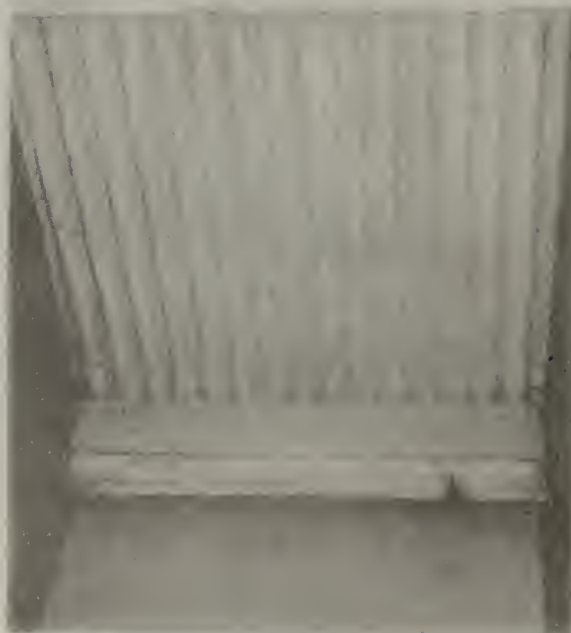
Figure A.4. Stairwell ceiling adjacent to penthouse with no apparent damage to fireproofing

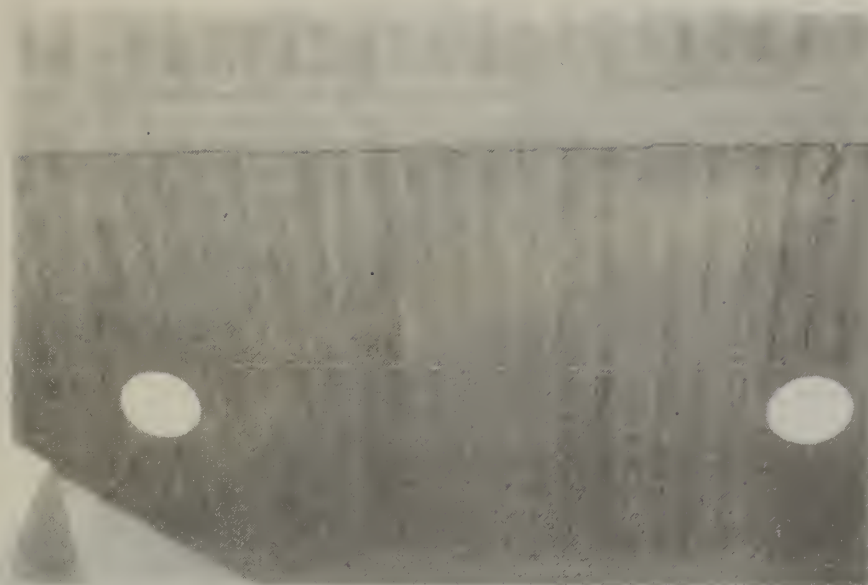
Figure A.5. Ceiling of window cleaning equipment room with no apparent damage to fireproofing

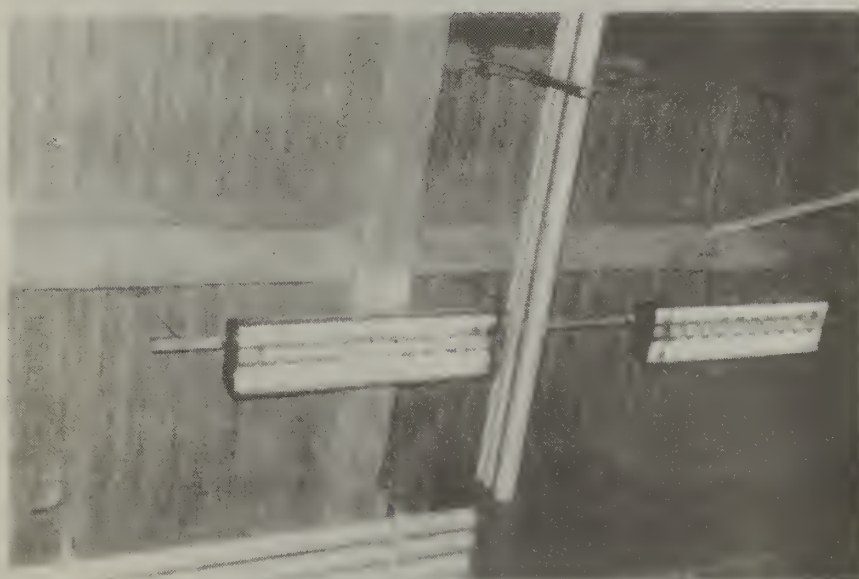
Figure A.6. Room 20408 - ceiling of electrical substation with no apparent damage to fireproofing

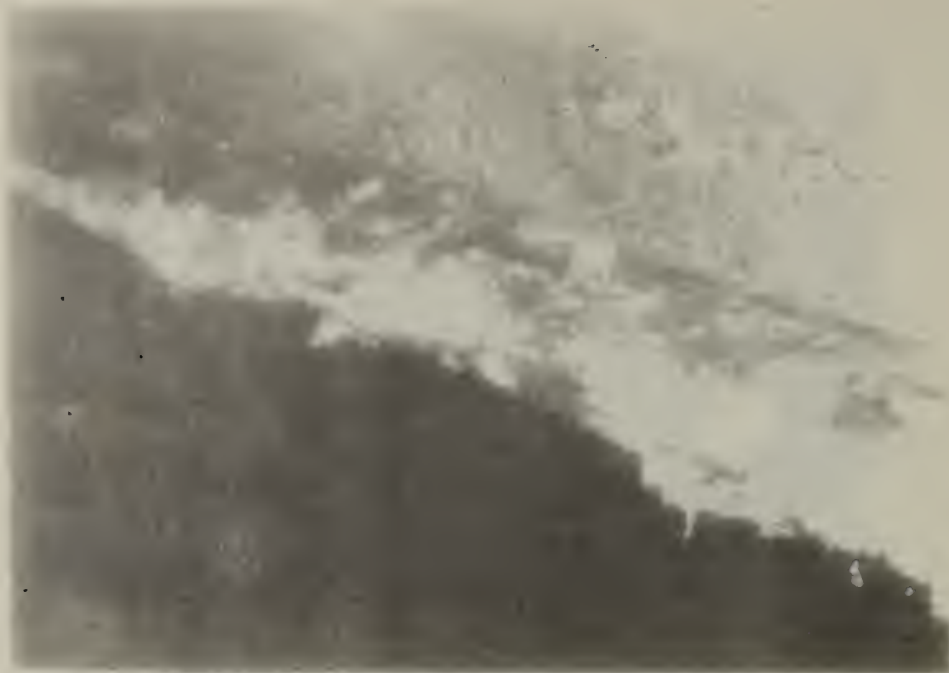
Figure A.7. Zone 3 elevator hoist room adjacent to roof - physical damage to fireproofing on beam caused by roofing contractor.

Option 6 - Remove fireproofing only in areas where heavy physical damage has occurred, such as in areas of the Zone 3 Elevator Hoisting Room (appendix A, figure A.7). Specifically, fireproofing should be removed only in areas where damaged.

Discussion and Approach - Removal of heavily damaged fireproofing should be done by a qualified contractor under prescribed environmental controls and in accordance with EPA 40 CFR, Part 61, OSHA 29 CFR 1910.1001, and applicable State and local regulations. Additional study will be required to identify areas

requiring removal. Where fireproofing is removed, it will be necessary to restore the fire rating.

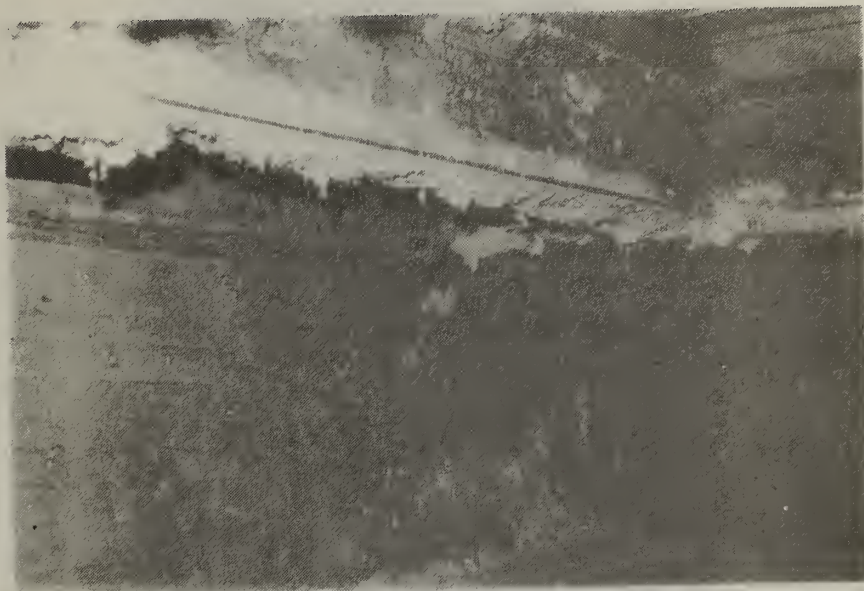
Figure A.9. Zone 3 elevator hoist room adjacent to roof - physical damage to fireproofing caused by roofing contractor

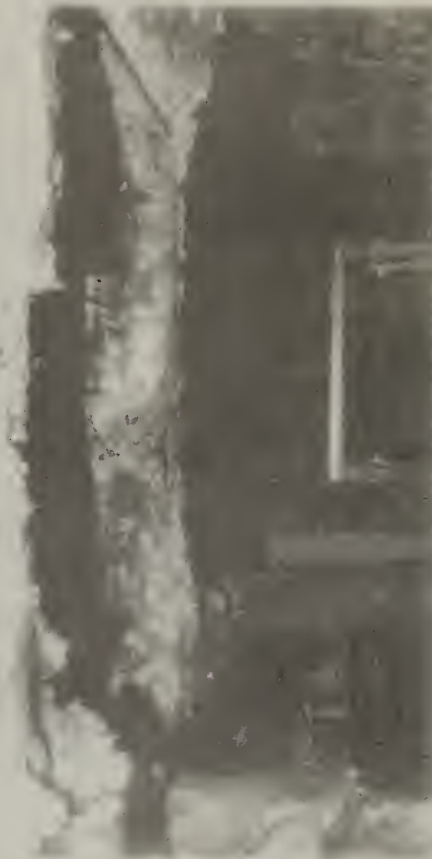
Figure A.10. Zone 3 elevator hoist room adjacent to roof - physical damage to fireproofing caused by roofing contractor.

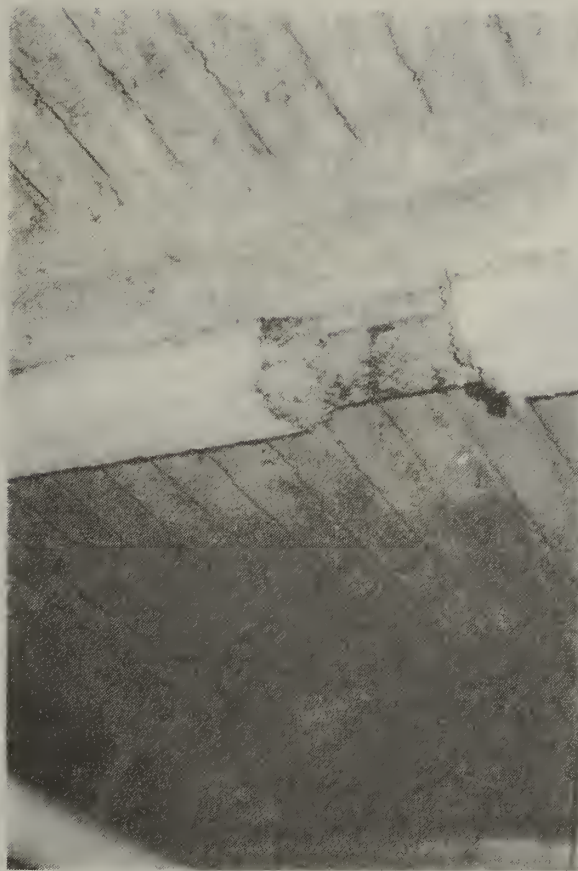
Figure A.11. Room 20408 - ceiling of electrical substation with portions of fireproofing removed from beam flange

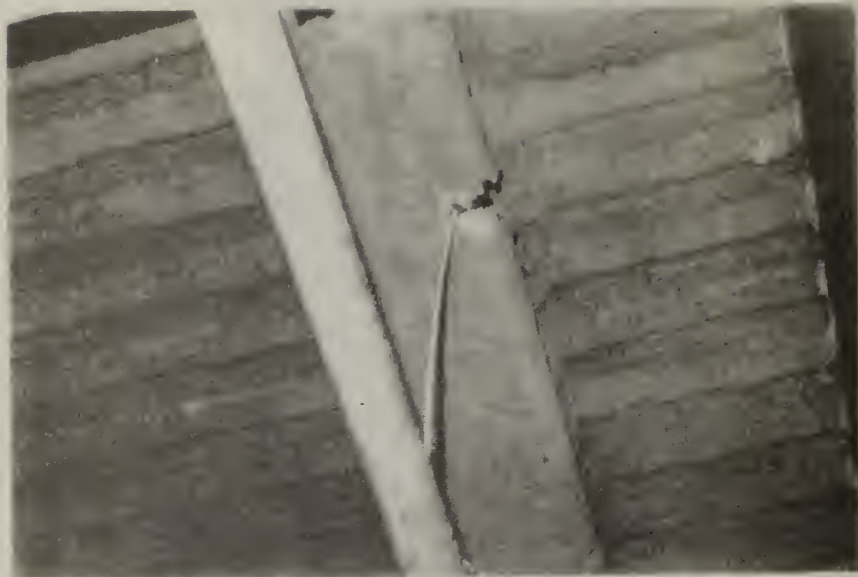
Figure A.12. Room 11006 - ceiling of electrical closet with physical damage to fireproofing caused by installation of hanger

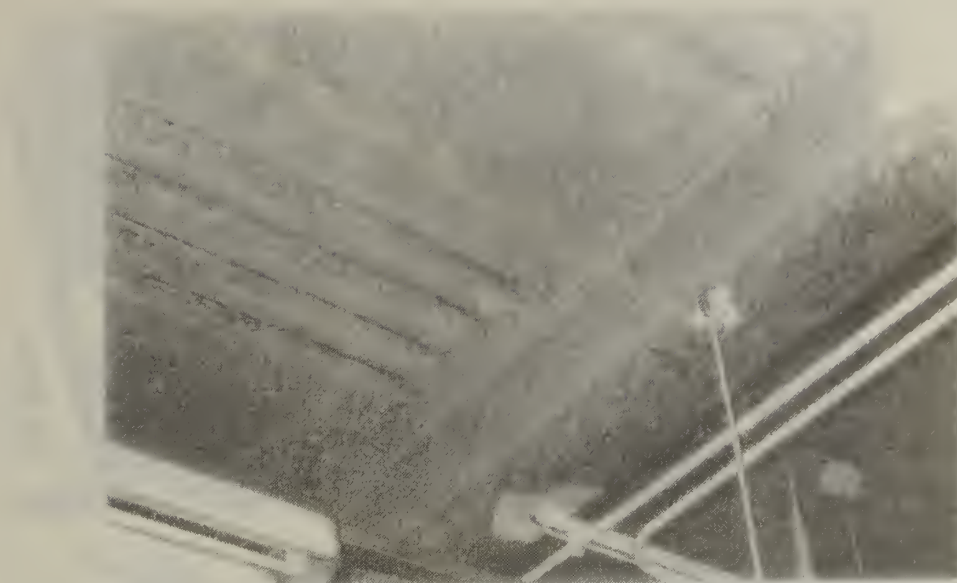
Figure A.13. Room 12207 - ceiling of zone 1 elevator machine room showing patching of fireproofing damaged during installation of hangers for ductwork

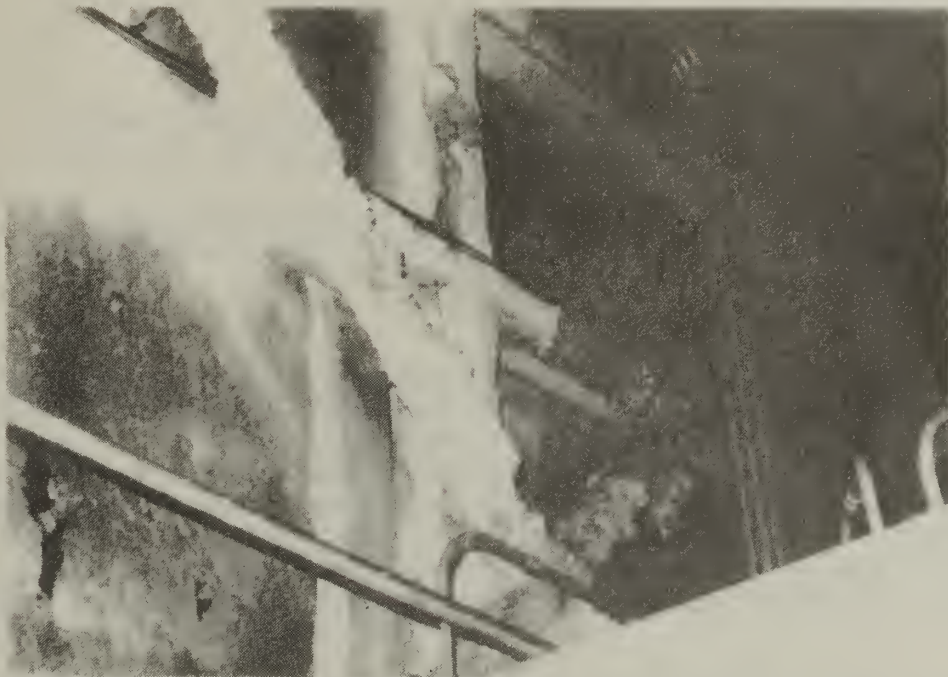
Figure A.17. Upper elevator for machine room - damaged fireproofing on structural bracing members

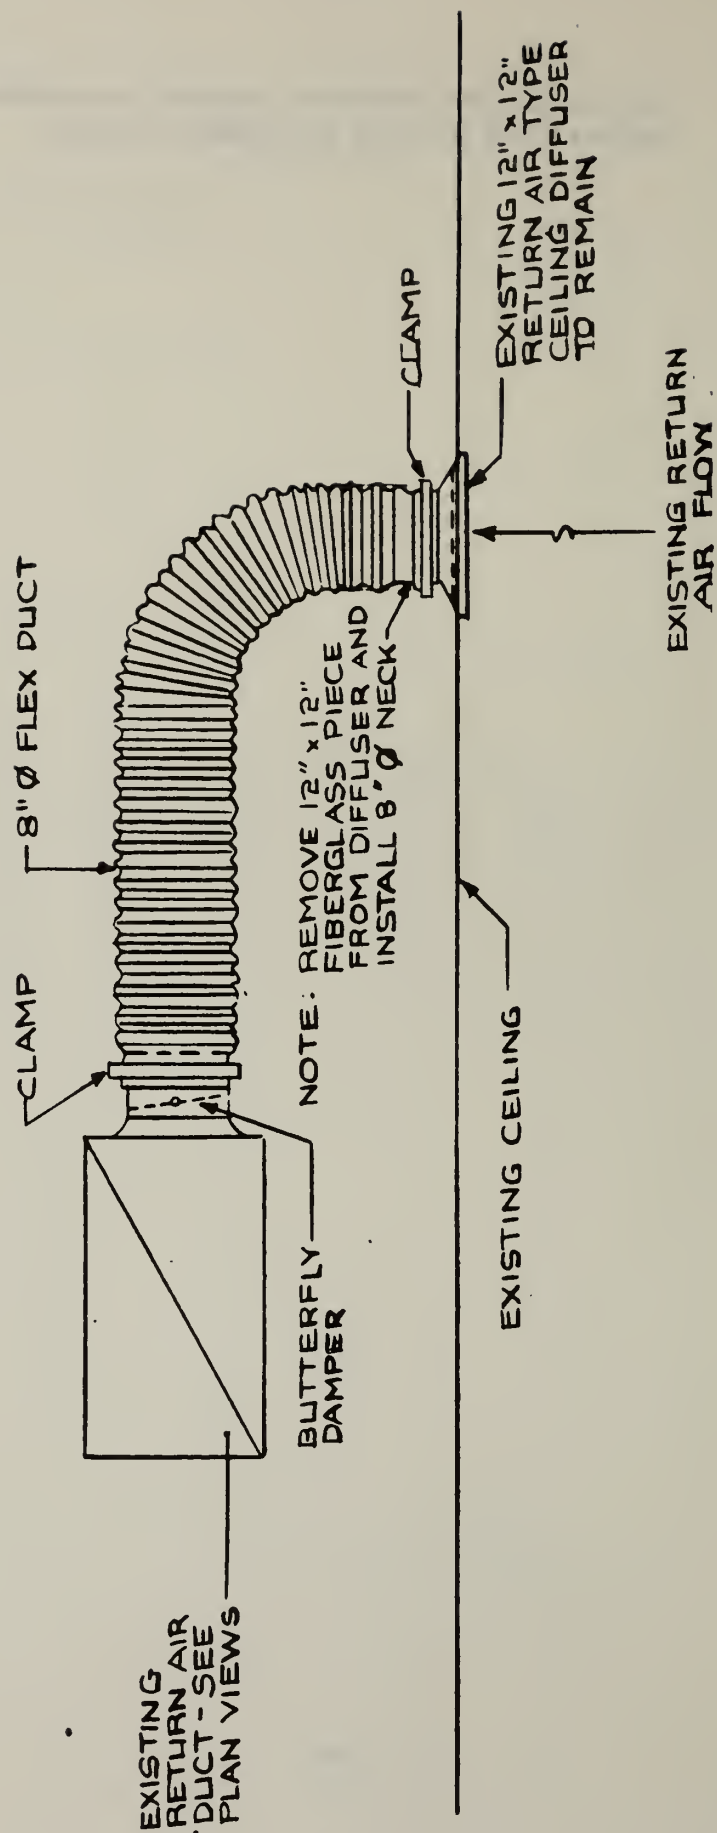
Figure E.1. Detail of connection of return air diffuser to existing return air duct

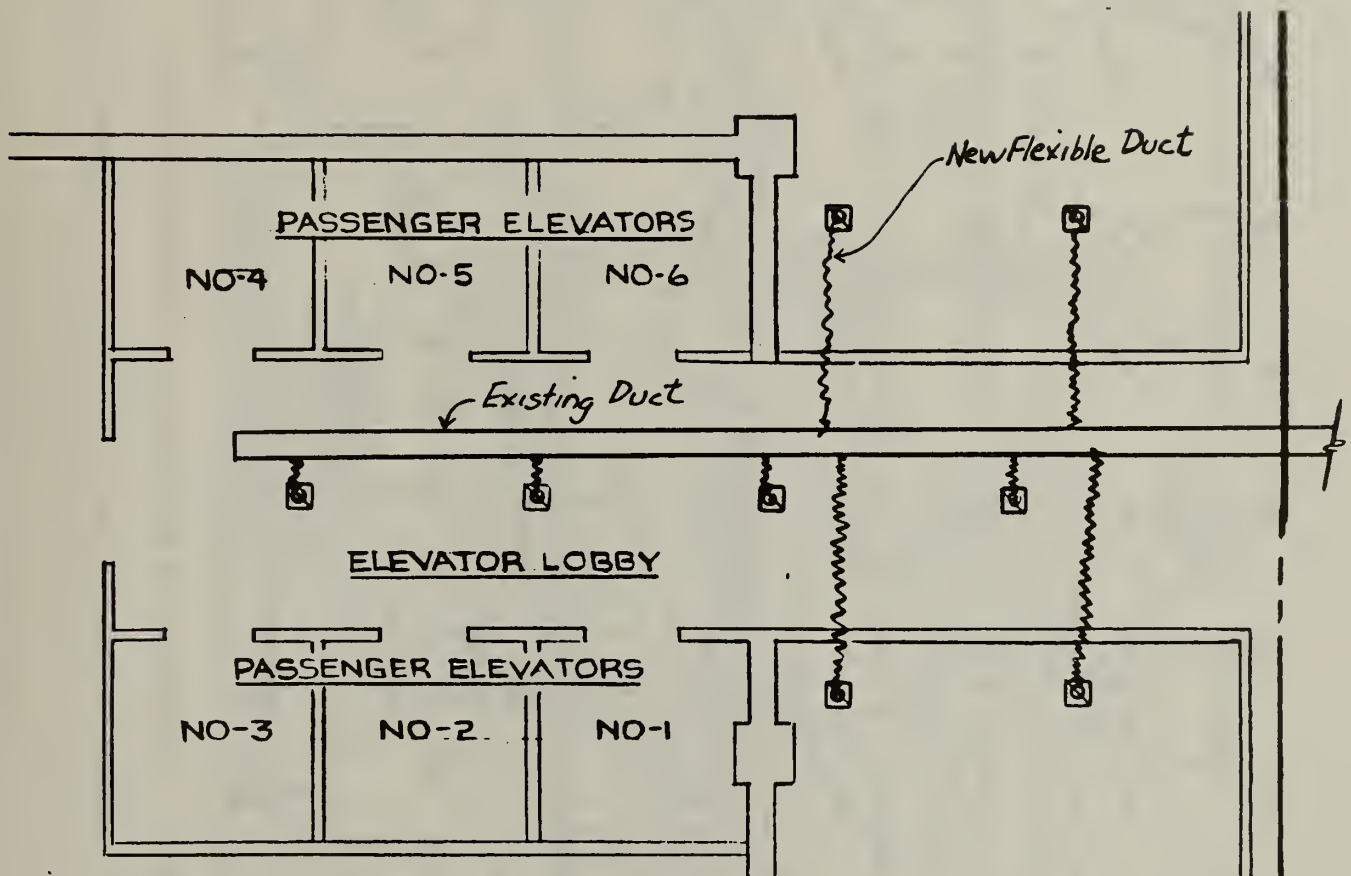
Figure E.2. Method of ducting air returns in elevator lobby areas

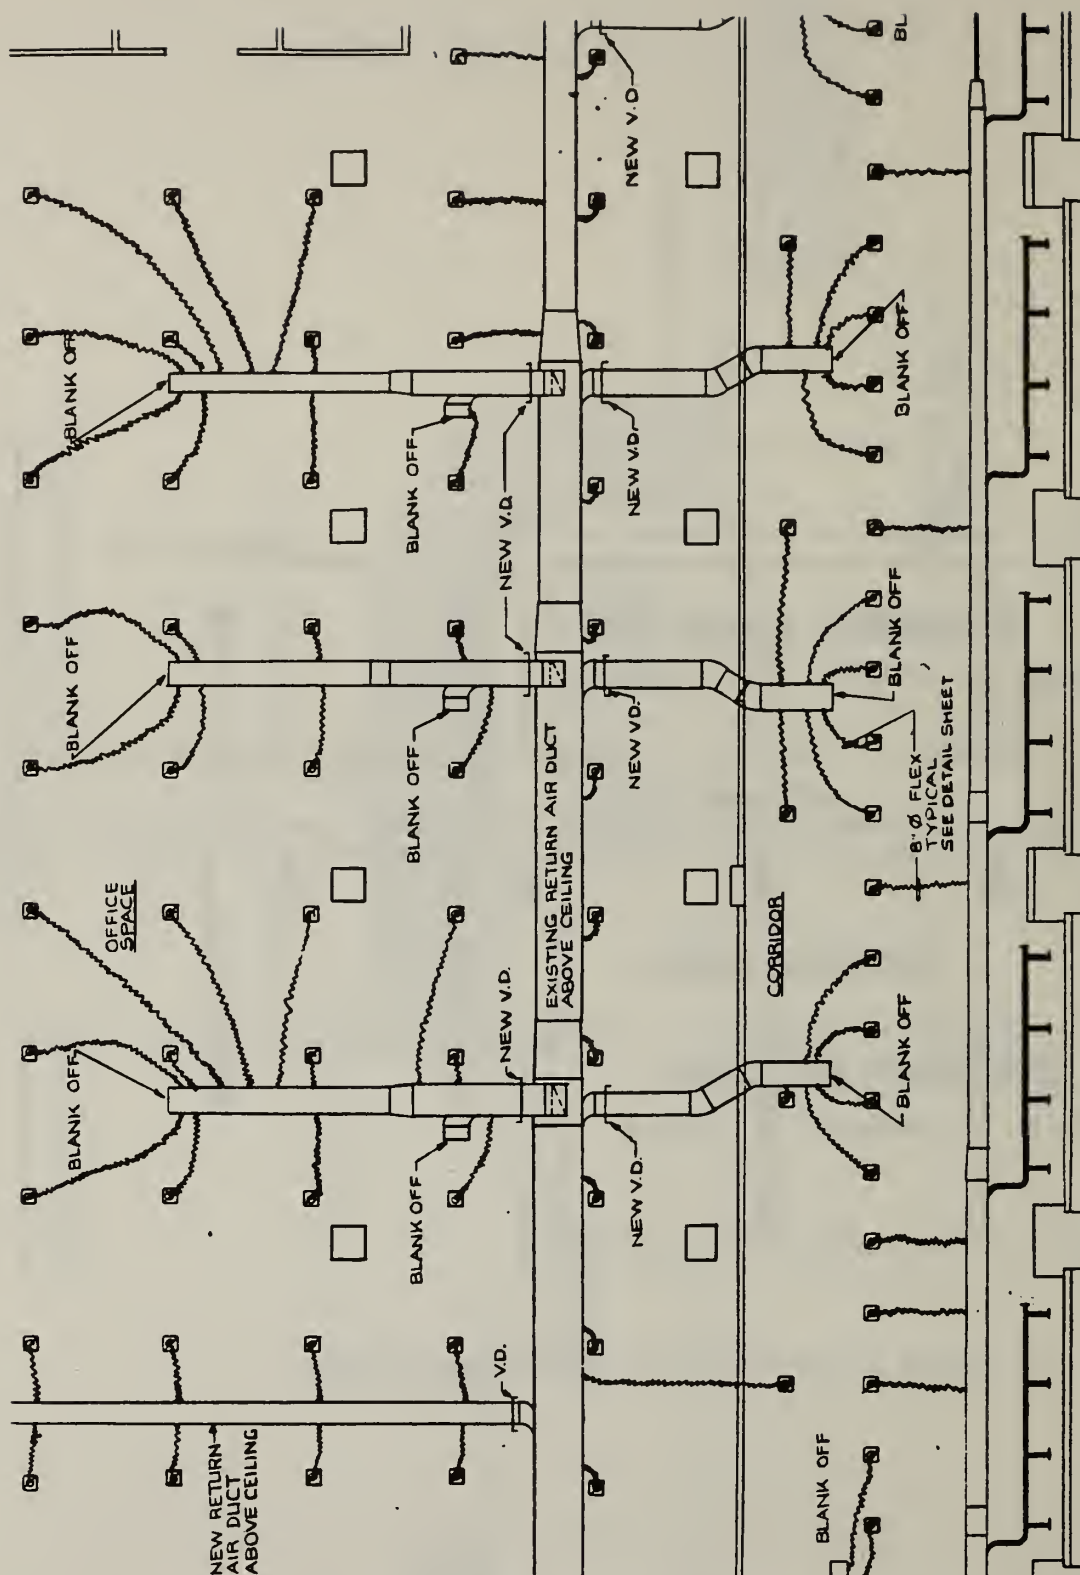
Figure E.3. Method for ducting air returns along perimeter of building

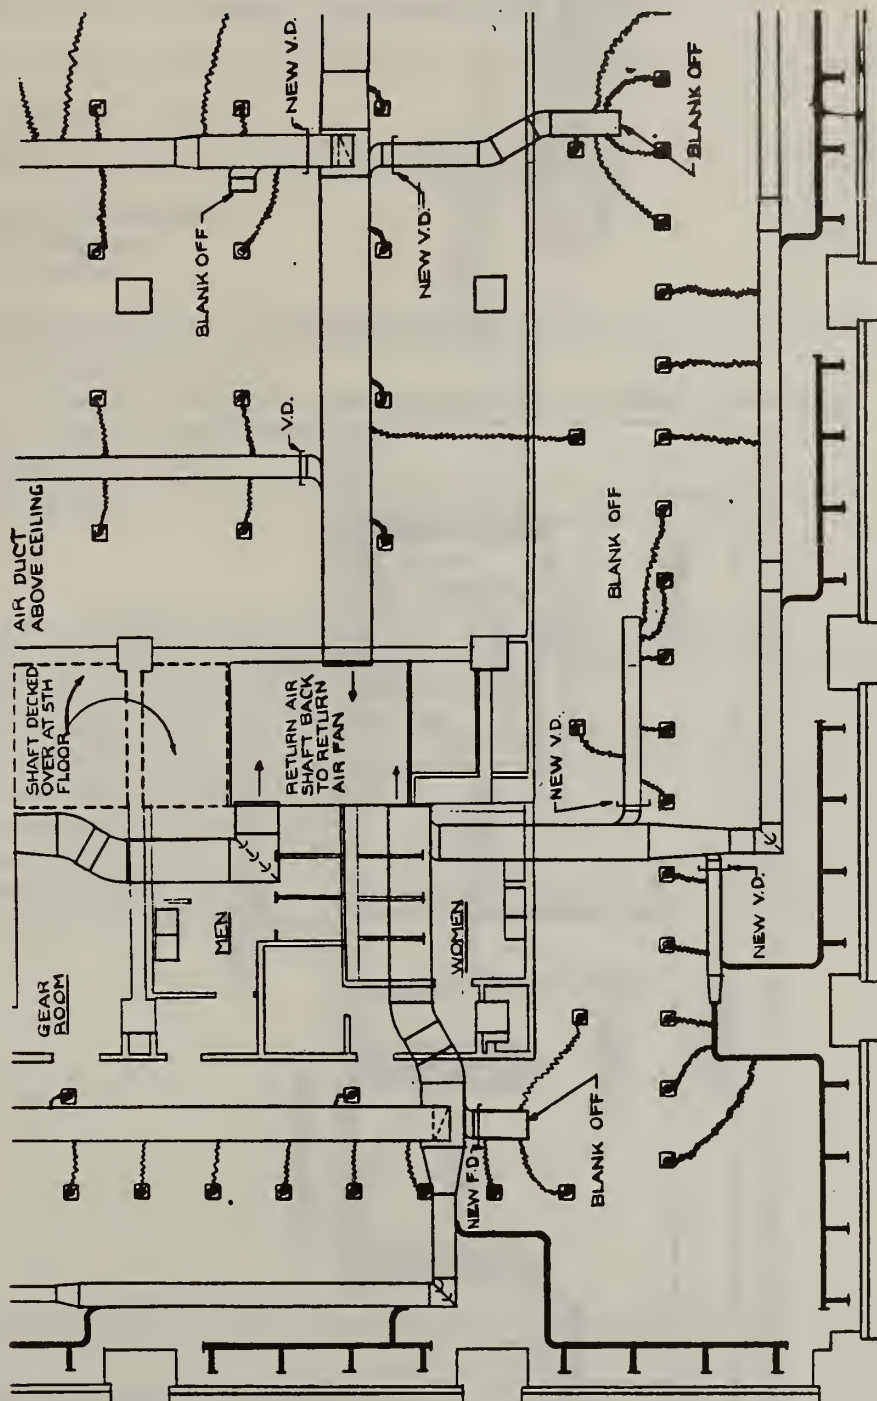
Figure E.4. Method for ducting air returns in corner section of building
